New York State Department of Transportation
Yellow Flag 1B19VLW058

BIN: 3306370
Feature Carried: BATTEN-DUGAN ROAD
Feature Crossed: BATTEN KILL
Orientation: 8 - NORTHWEST
Region: 01 - ALBANY
County: WASHINGTON
Political Unit: Town of JACKSON
Approximate Year Built: 1916
Posted Load Matches Inventory : Yes
Bridge Load Posting (Tons) : 20
Primary Owner: 30 - County
Primary Maintenance Responsibility: 30 - County
Typical or Main Span Type: 3 - Steel, 10 - Truss - Thru
This Bridge is not a Ramp
Number of Spans: 1

Subject: Right Truss (T2) Bottom Gusset Plate Section Losses
(Bridge posted for 20 tons)

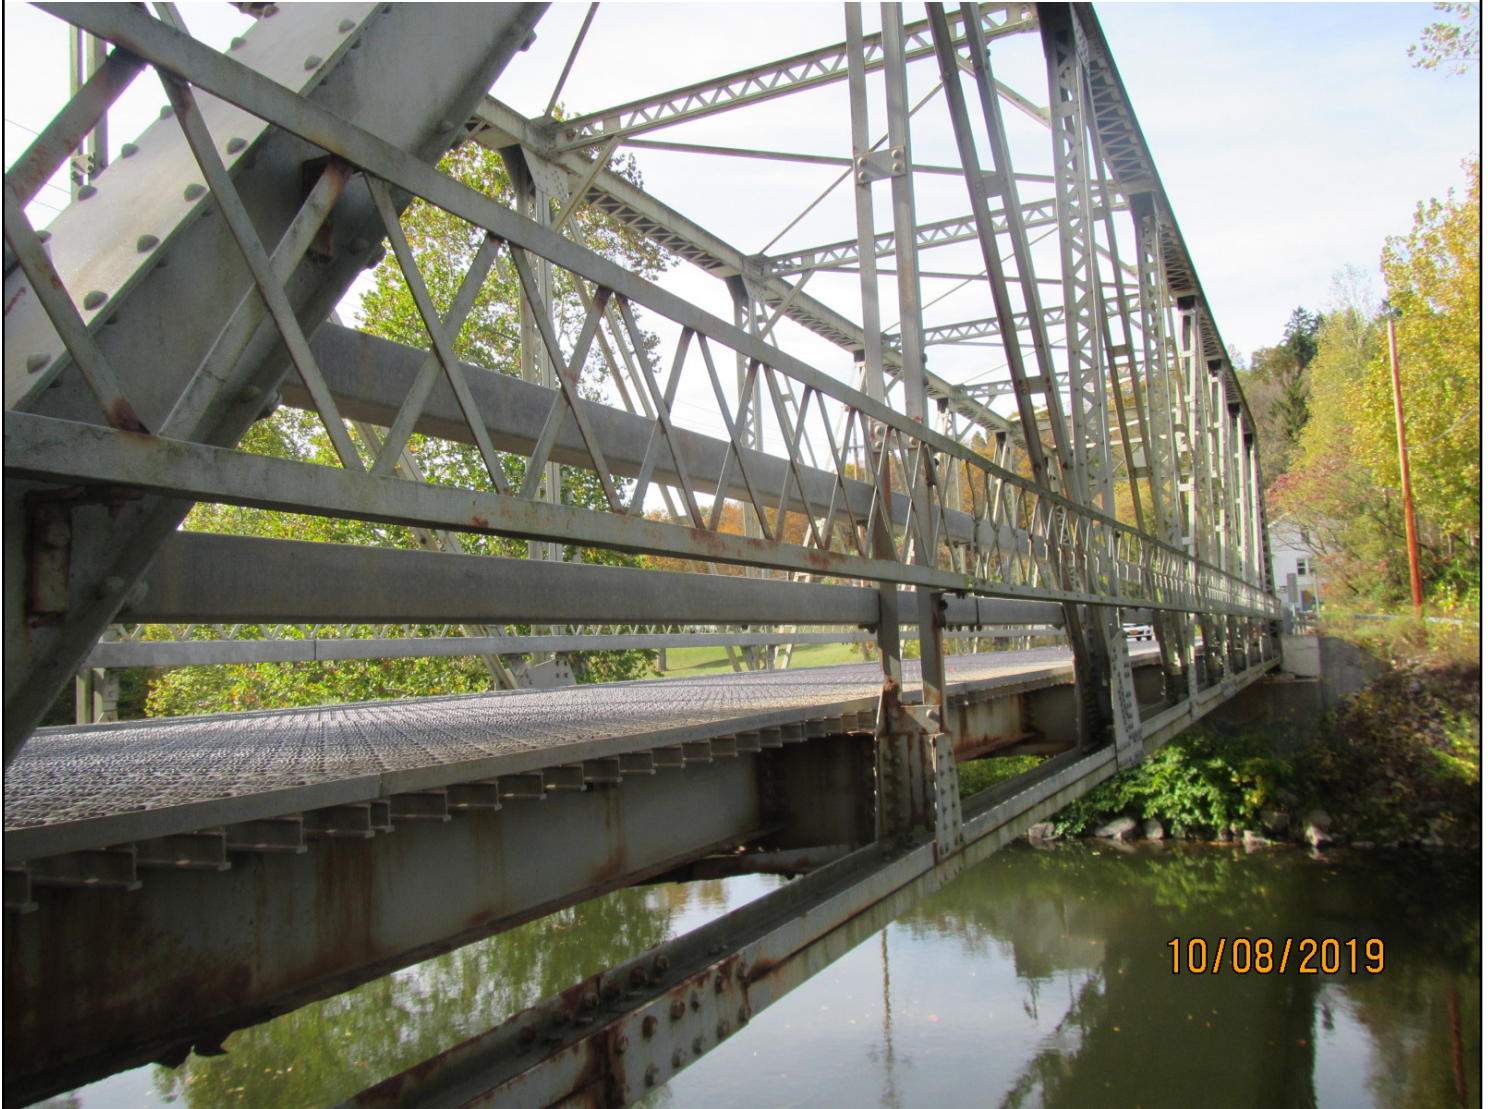
Photo Number: 1

Attachment Description: Right Truss looking at End – General Configuration

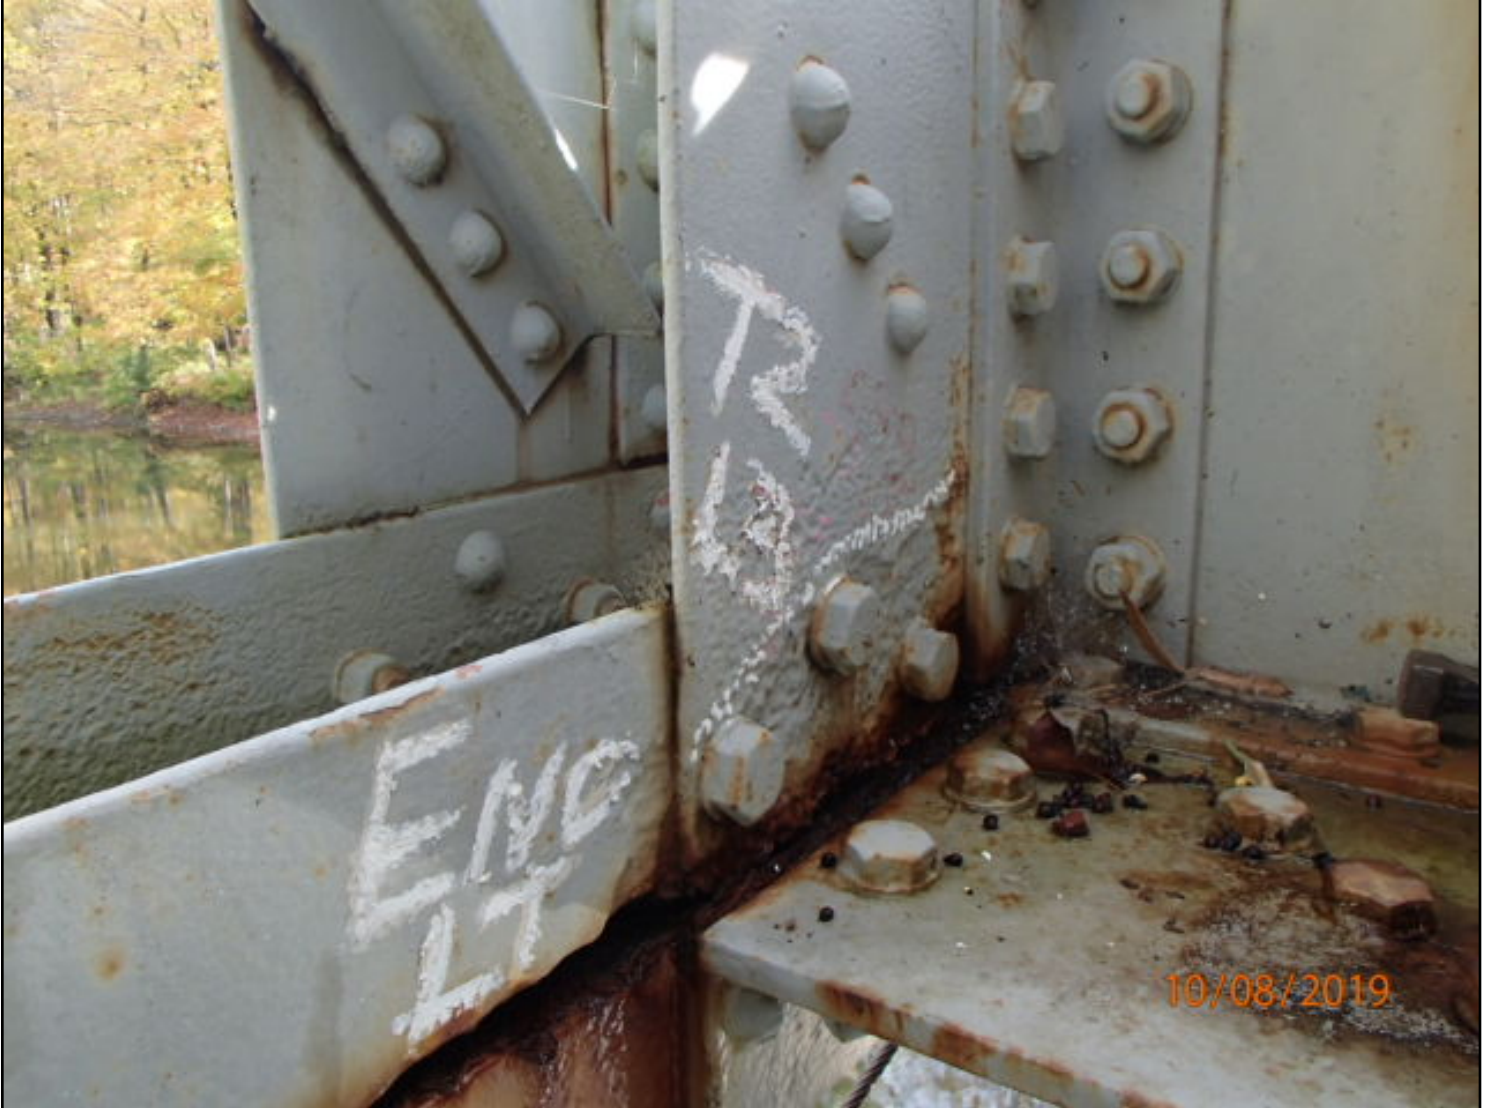
Photo Number: 2

Right Truss (T2) at L3: End Left Plate – 75% SL with a perforation over 7 in long x 1 in high (2018 - 75% SL with perforation 6.5 in long); (Photos 2 and 3)

Attachment Description: Right Truss, End Left Gusset Plate at L3

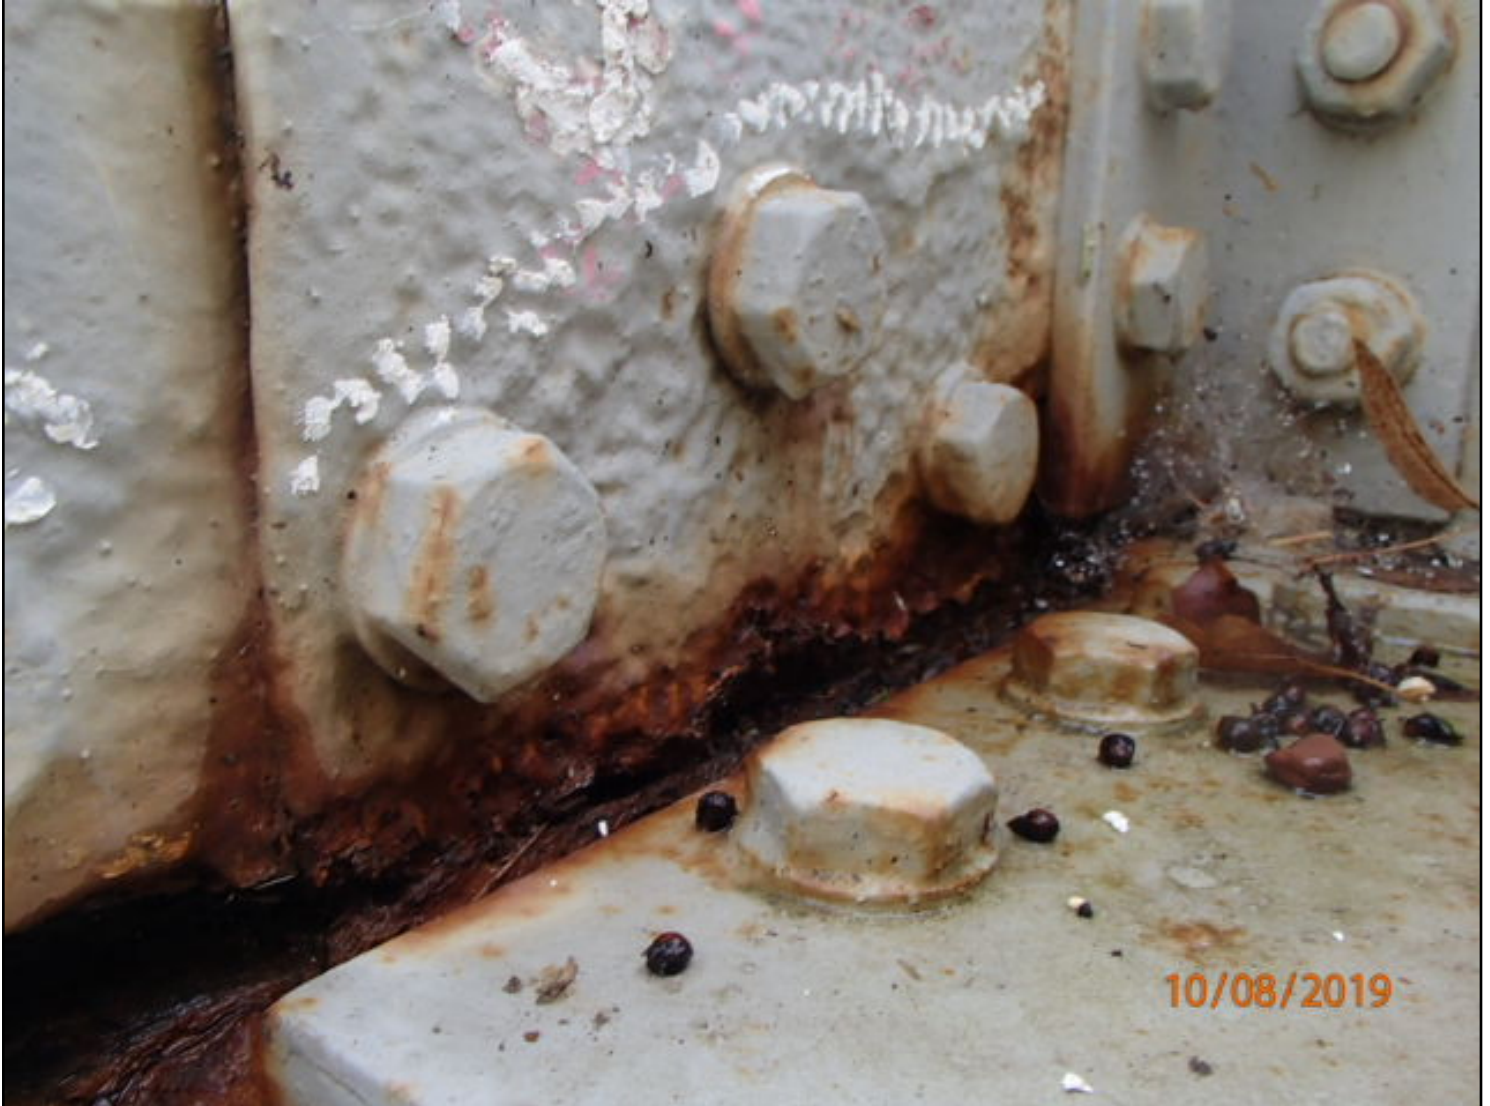
Photo Number: 3

Attachment Description: Right Truss, End Left Gusset Plate at L3 with perforation

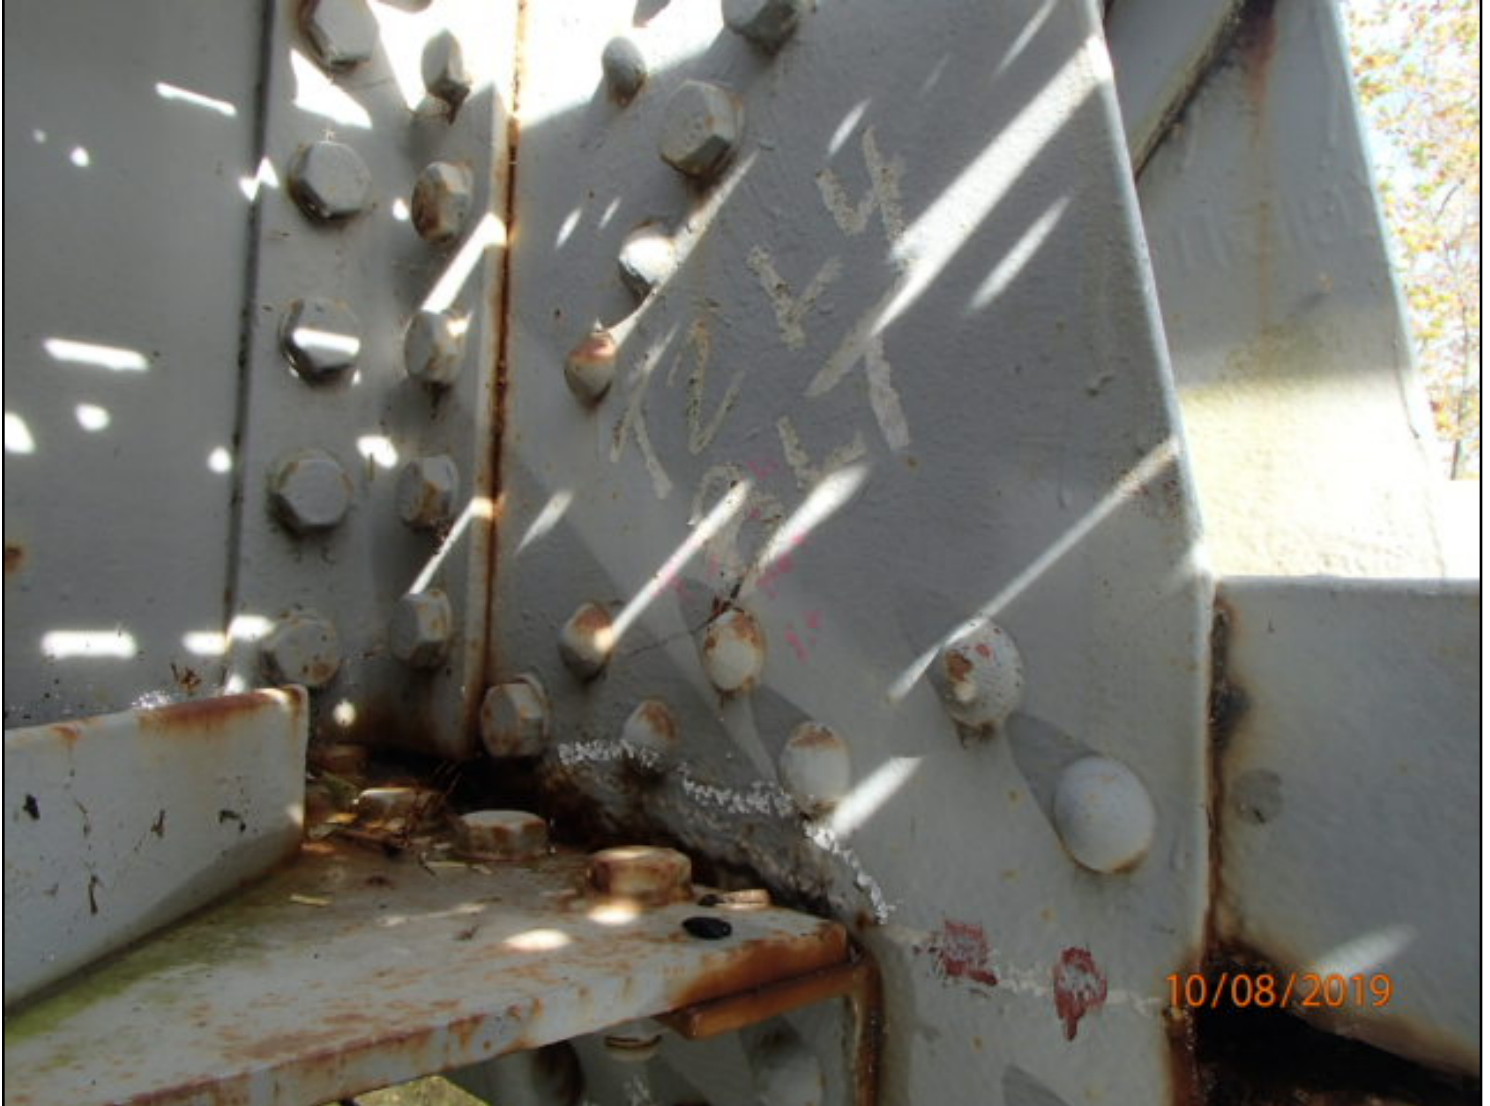
Photo Number: 4

Right Truss (T2) at L4: Begin Left Plate - 30% SL (new location); (Photo 4)

Attachment Description: Right Truss, Begin Left Gusset Plate at L4

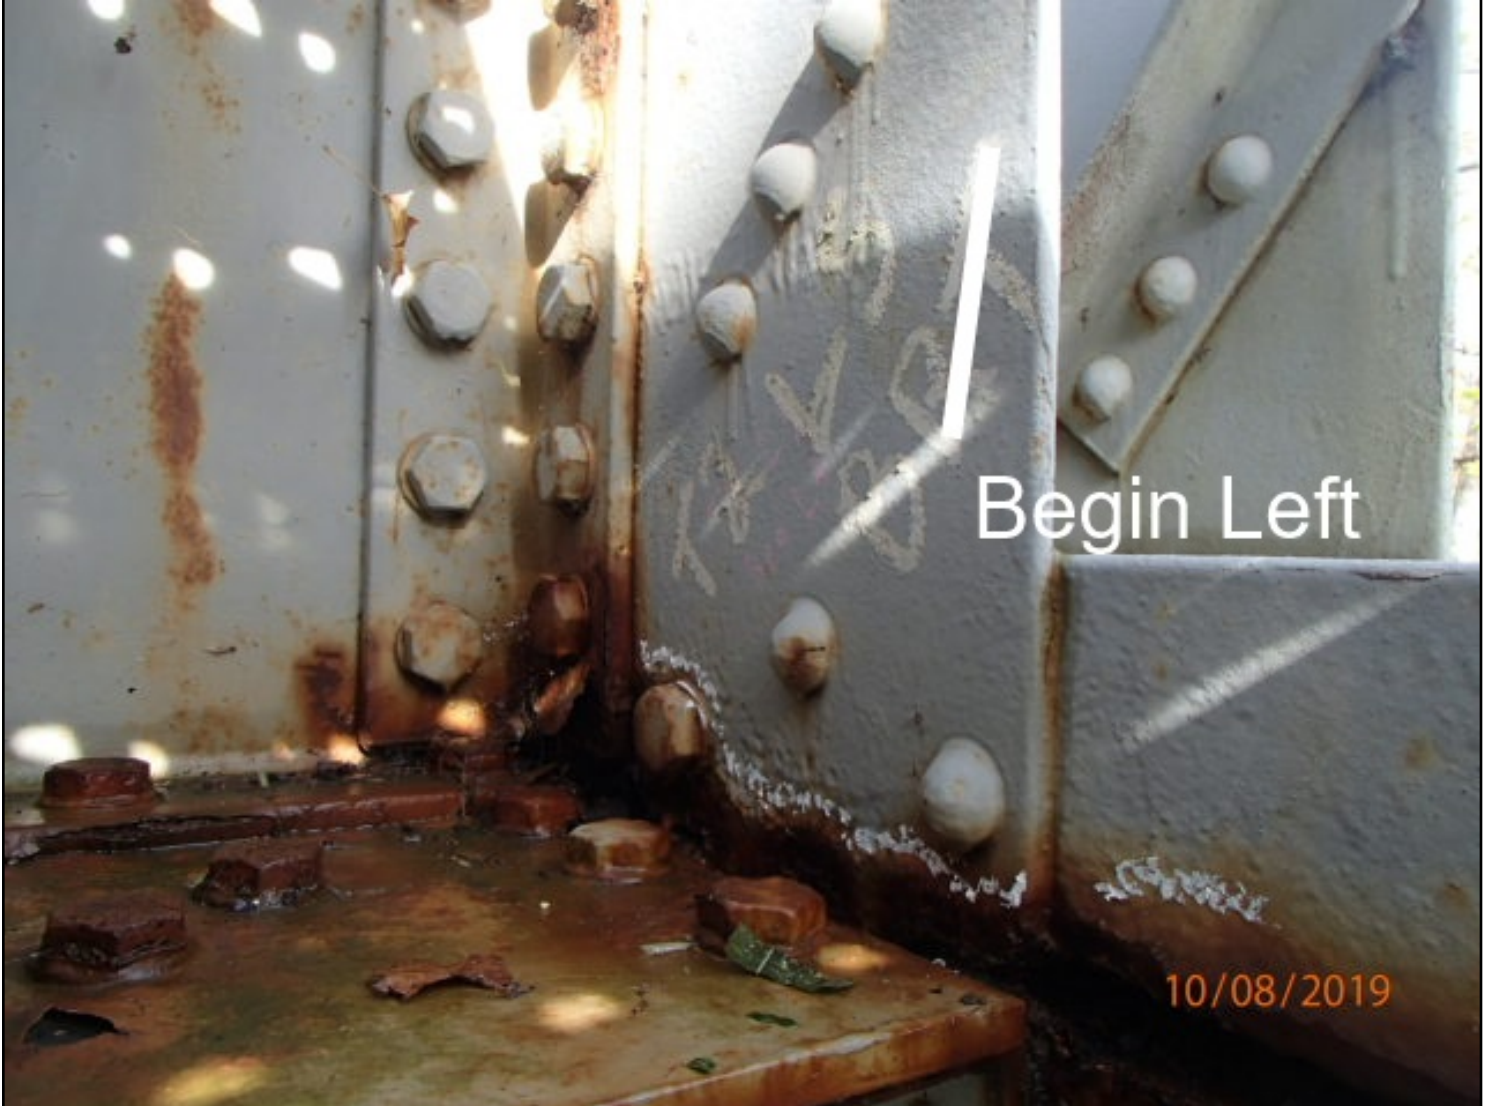
Photo Number: 5

Right Truss (T2) at L5: Begin Left Plate - 70% SL with 4 perforations 1 in long x 1 in high (2018 – no change); (Photo 5)

Attachment Description: Right Truss, Begin Left Gusset Plate at L5

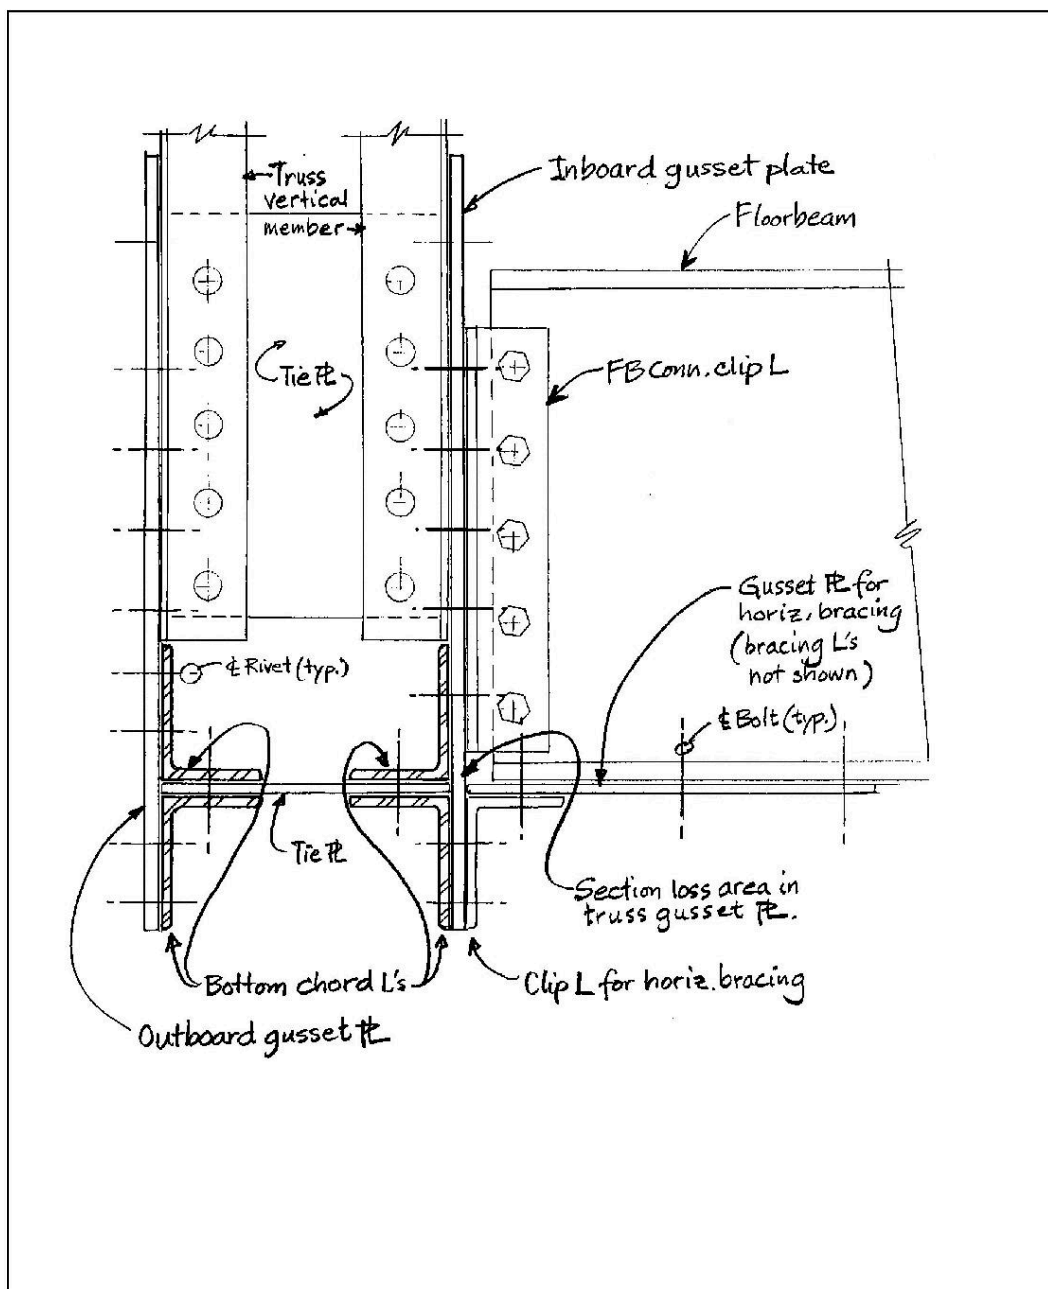
Photo Number: 6

This is a single span thru-truss bridge with an open steel grate deck. The bridge is 128 ft long and has 8 panels. The truss members are made up of angles (4) for the verticals, diagonals, top and bottom chords. The majority of the section losses to the bottom gusset plates are on the Left plates (interior face). The section loss in many areas pre-date the existing paint system but shows signs of active corrosion due to paint failure. Losses were calculated with a pit gauge due to the location of the vertical and horizontal gusset plate and bottom chord. The section losses were located between the bottom chords top angle and bottom angle. Section losses are along a horizontal band width of 1 to 1.5 in high x 14 to 21 in long. (See Truss Bottom Chord Sketch) The gusset plates are 7/16 in thick.

**Attachment Description: Truss Bottom Chord Sketch**
